# Archaeology Research Grant 2022

5. Title of project Portal tomb construction: Doogort West, Achill Island, Co Mayo

Portal Tomb Construction  
Doogort West  
Slievemore, Achill Island, Co Mayo

# Portal tomb construction: Doogort West, Achill Island, Co Mayo

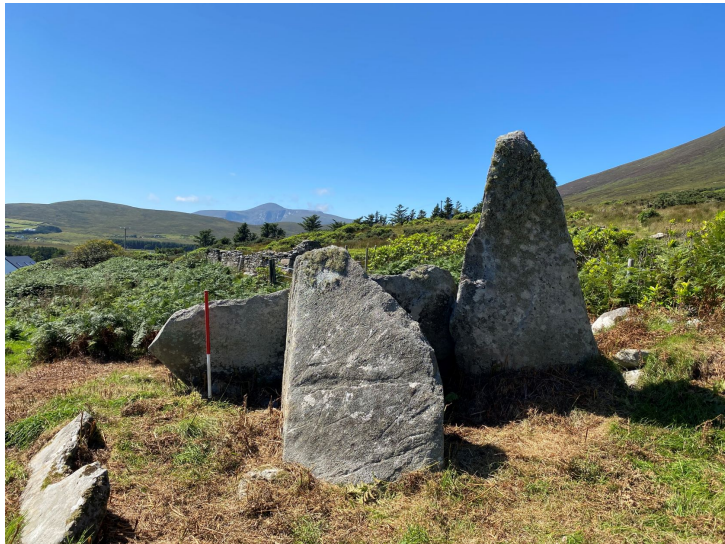
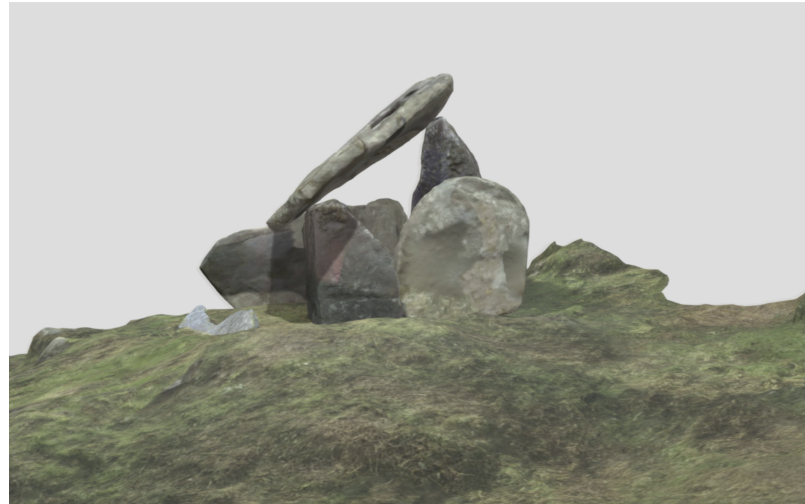
(Recon)

<https://skfb.ly/ozF7Z> The reconstruction:

**Please outline the objectives of the project:** It was proposed to undertake a detailed laser scan survey of the site, including its component parts and the surrounding area. Each element, some 6 orthostats and the large capstone, lying to the south east, were scanned separately. Uniquely this allowed for the constructional elements of the Portal Tomb to be virtually manipulated individually.

The survey was undertaken in such a way as to allow each of the structural elements to be manipulated separately. Consequently it was possible to re-straighten each of the orthostatic elements and to 'reattach' the two broken pieces of the orthostat located to the northeast of the tomb. With this configuration in place, the cap stone was repositioned on the three highest points of the structure; the top of the main portal stone, the top of the smaller southeast orthostat and on the side of the orthostatic side slab (Figs. 3 - 6). The shape of the capstone, square on three sides with the fourth angled, meant that one of the edges was markedly shorter than the other three. Given these constraints, the modeling suggested that there was only a limited number of positions that the capstone could rest satisfactorily on the underlying orthostats. When the post-collapse position of the capstone was factored in it was clear that the straight edge of the capstone must have faced west, with the shorter side facing north and the angled side facing east.

The reconstruction was shown to a structural engineer who considered that if the reconstruction was correct and the smaller southeast orthostat were the first to shift inwards and to the west, this would cause the cap stone to shift southeastwards and potentially end up in its current position. Finally, the survey allowed for each of the stones to be laser printed at a scale of 1:20, which allows for the proposed virtual reconstructions to be tested manually.

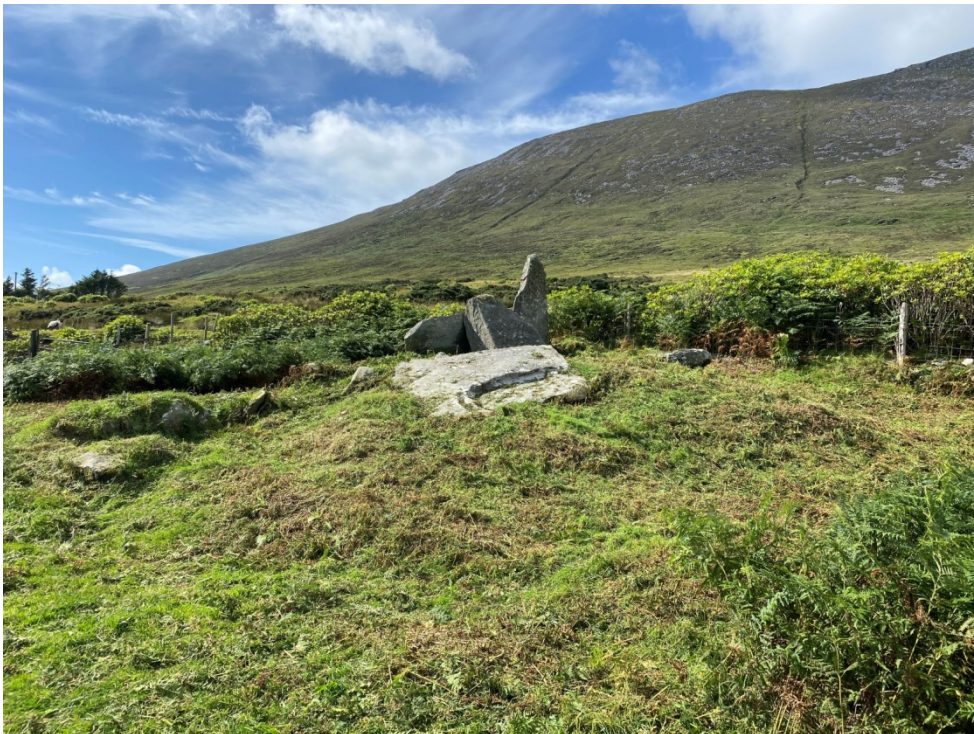
Plate 1. General view of site from the southeast showing remains of possible cairn on the east side

A large prostrate stone lying on the cairn at the south-east is very probably the displaced roof stone (Plate 1). It is 2.75 m. in maximum dimension. Its north-west edge shows a clean break which looks comparatively recent (Plate 5). De Valera and O'Nualain were informed locally that the slab was fractured by the lighting of a bonfire upon it and that the detached portion was used as a lintel in a nearby house (see front cover). The stone is 0.45 m. thick at its north-east corner, and tapers to 0.20 m.

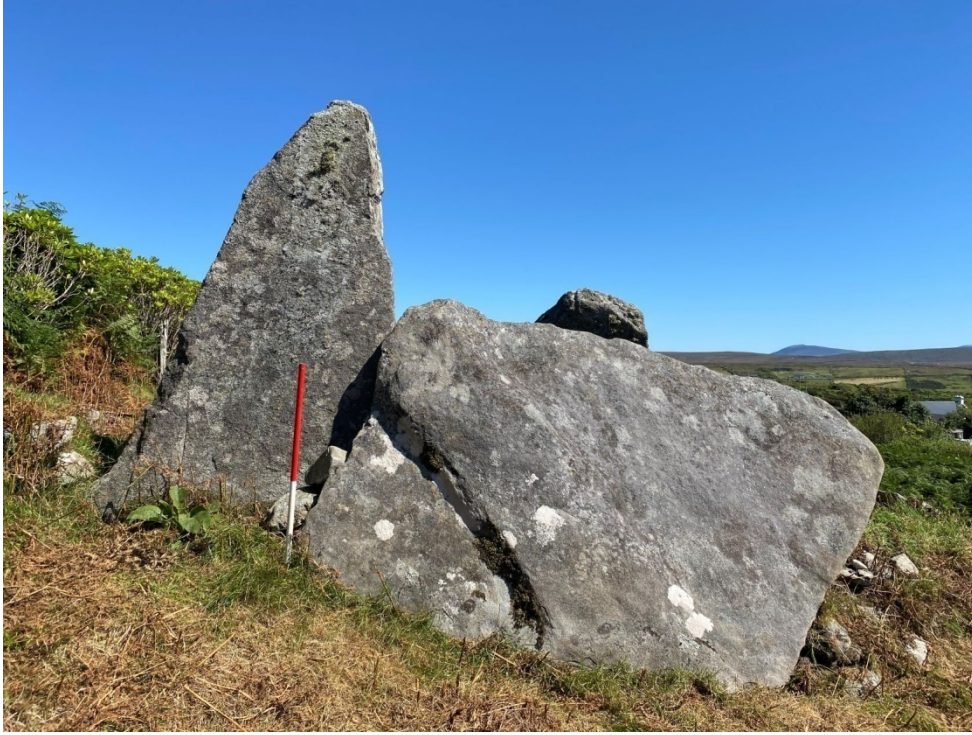
Plate 2. West facing elevation

Two slabs forming the west side of the chamber remain in situ (Plate 2). The northern is a fine tall portal stone 2.30 m. high. It leans slightly to the east. It tapers from 1.30 m. long at the base to 0.25 m. at the top.

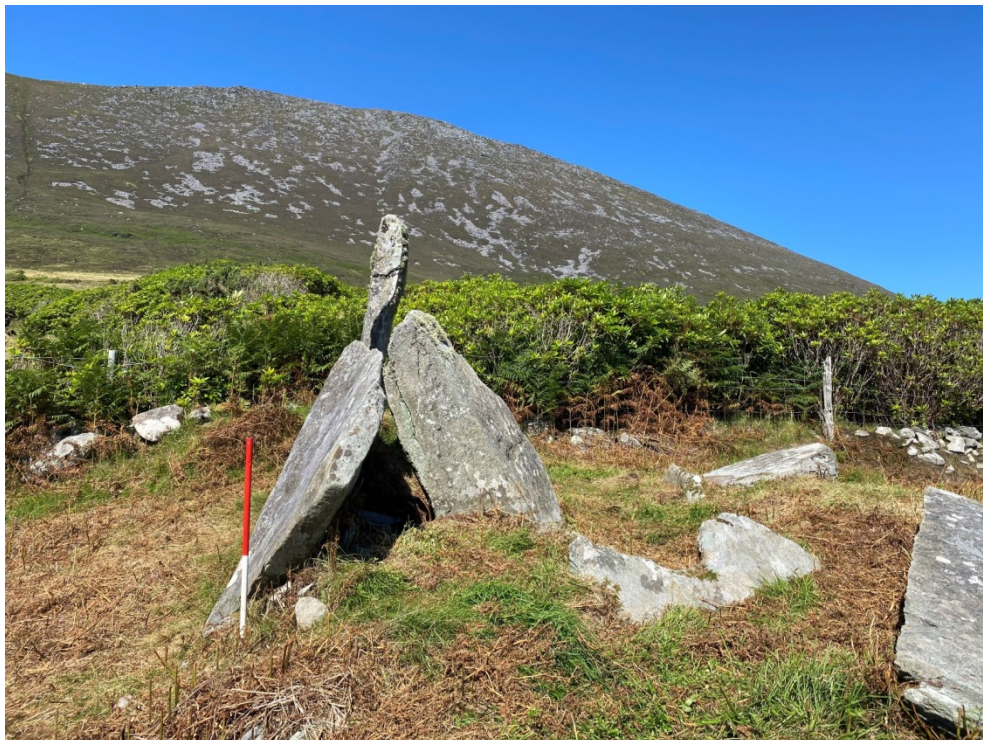
Plate 3 South facing elevation

Leaning against the east side of this slab is a stone 1.90 m. high (Plate 3). It too tapers, from 1.00 m. long at the base to 0.35 m. near the top. It may not be in situ, but its shape suggests that it may have

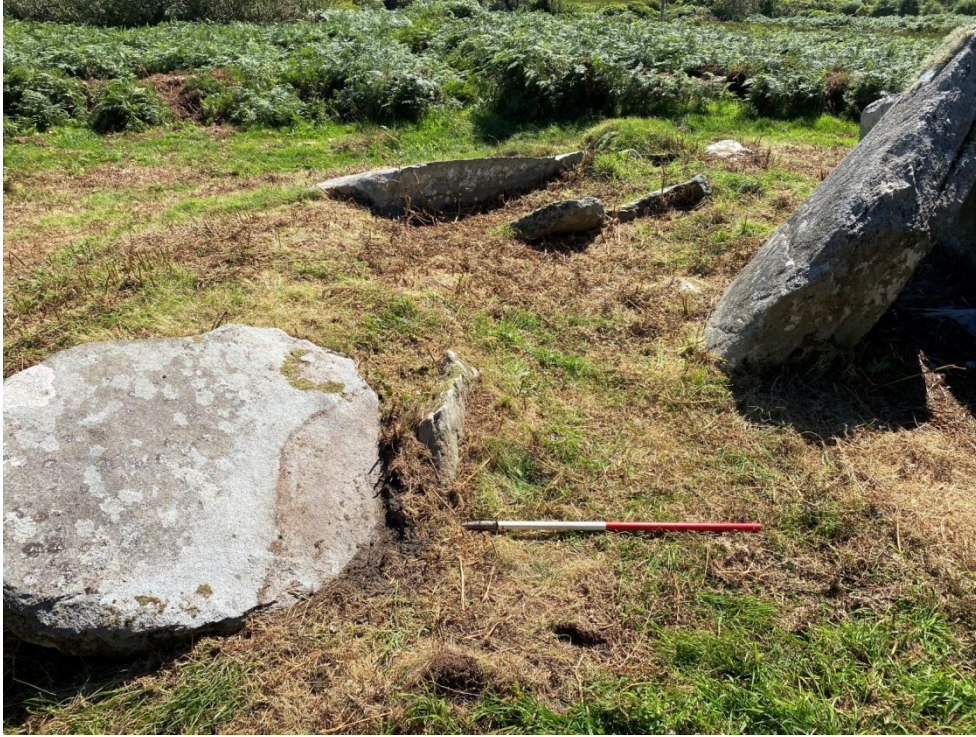
Plate 4. The possible backstone back right with the apparently broken orthostat front left

About 1.20 m. south of the last and running askew to the main axis of the chamber, as indicated by the western side, is a set stone, 0.60 m. high, leaning heavily to the north-west (Plates 4 and 5). Its top edge is irregular and appears to have been damaged. The function of this stone is not altogether certain but it may well be the backstone of the chamber.

2.50 m. east of the portal stone the base of a set slab protrudes 0.25 m. from the ground (Plate 4). Its function is not clear. It can scarcely be the base of a portal stone as the gap of 2.50 m. between it and the surviving portal would be unusually wide. Just east of this is a slab 1.15 m. high which leans heavily to the east. Its edges are rounded. It is probably the stone referred to by O'Donovan of which 'an impious miller commenced to make a millstone.' Its original function is unknown.

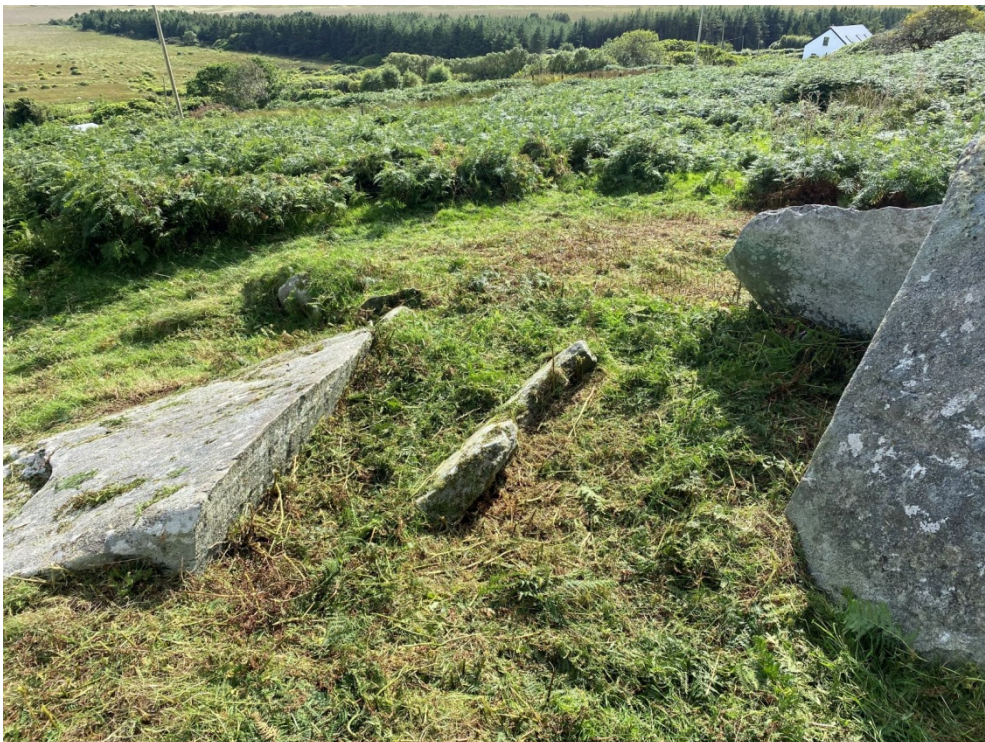
Plate 5 The possible backstone from the east and the straight edge of the probable roofstone

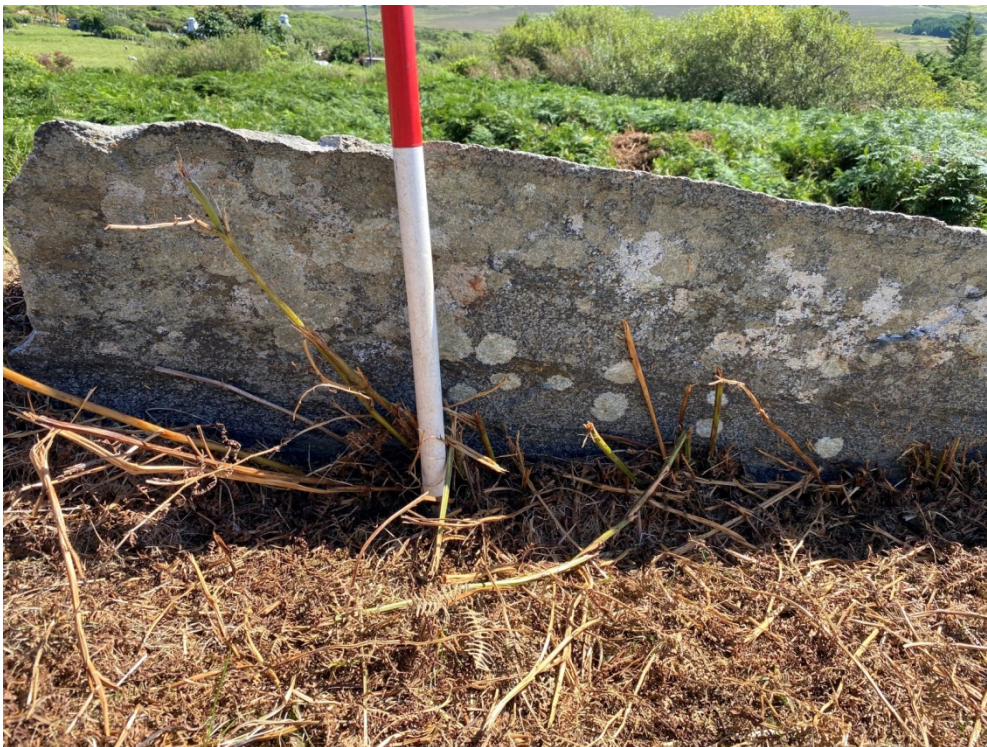
Plate 6 Detail of lichen growth on straight face of cap stone

This roof stone has been the subject of some speculation. De Valera and O’Nuallain noted that it’s ‘north-west edge shows a clean break which looks comparatively recent’, going on to relate a local story which recounted ‘that the slab was fractured by the lighting of a bonfire upon it and that the detached portion was used as a lintel in a nearby house.’ As part of the preparatory work to the present survey, the family of the owners of the ‘nearby house’ (see front cover) who are also the owners of the land on which the portal tomb is situated, were interviewed and while being aware of the story, are adamant that no structural elements of the tomb were used in the construction of their ancestral home. While it is not entirely conclusive, an examination of the ruined remains of the house, which is located some 15 m to the northwest of the portal tomb, did not reveal any stones, lintels or otherwise, which would fit the profile of the capstone. It is also noteworthy that the exposed ‘clean break’ as described by de Valera and O’Nuallain, is not really that clean at all. The exposed surface of the break is in fact covered in a variety of lichen species (Plate 6), some of which are notoriously slow growing, which are unlikely to have colonised the face of the stone had the

break occurred when the nearby house was built sometime in the early 19<sup>th</sup> century. It therefore must be concluded that the roof stone in its present state has remained unaltered since it was used in the construction of the portal tomb.

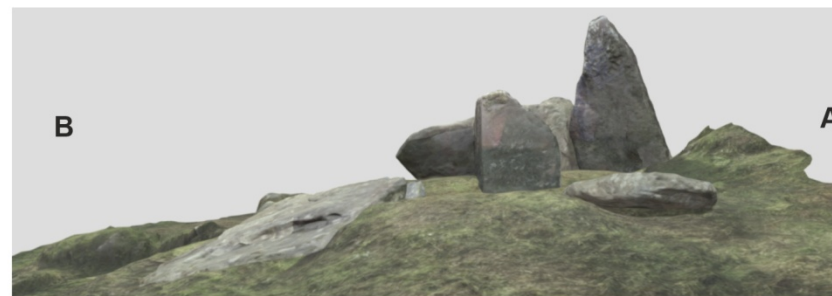
after de Valera & O'Nualain

Laserscan survey 2022

Fig. 2 Plans and elevations of the existing site from 1964 on left and 2022 on right

The tomb is very damaged. It consists of the ruins of a chamber orientated roughly north-south (Fig. 2). The grass-grown remains of a cairn are present at the east side of the chamber. Three fences join at the tomb. The first is the southern boundary of the old road and it runs east-west across the northern edge of the cairn. The second, which incorporates the west side of the chamber, runs north-south to meet the first. The remnants of the third fence can be traced running from the west to join the second fence 6.00 m. south of the road fence.

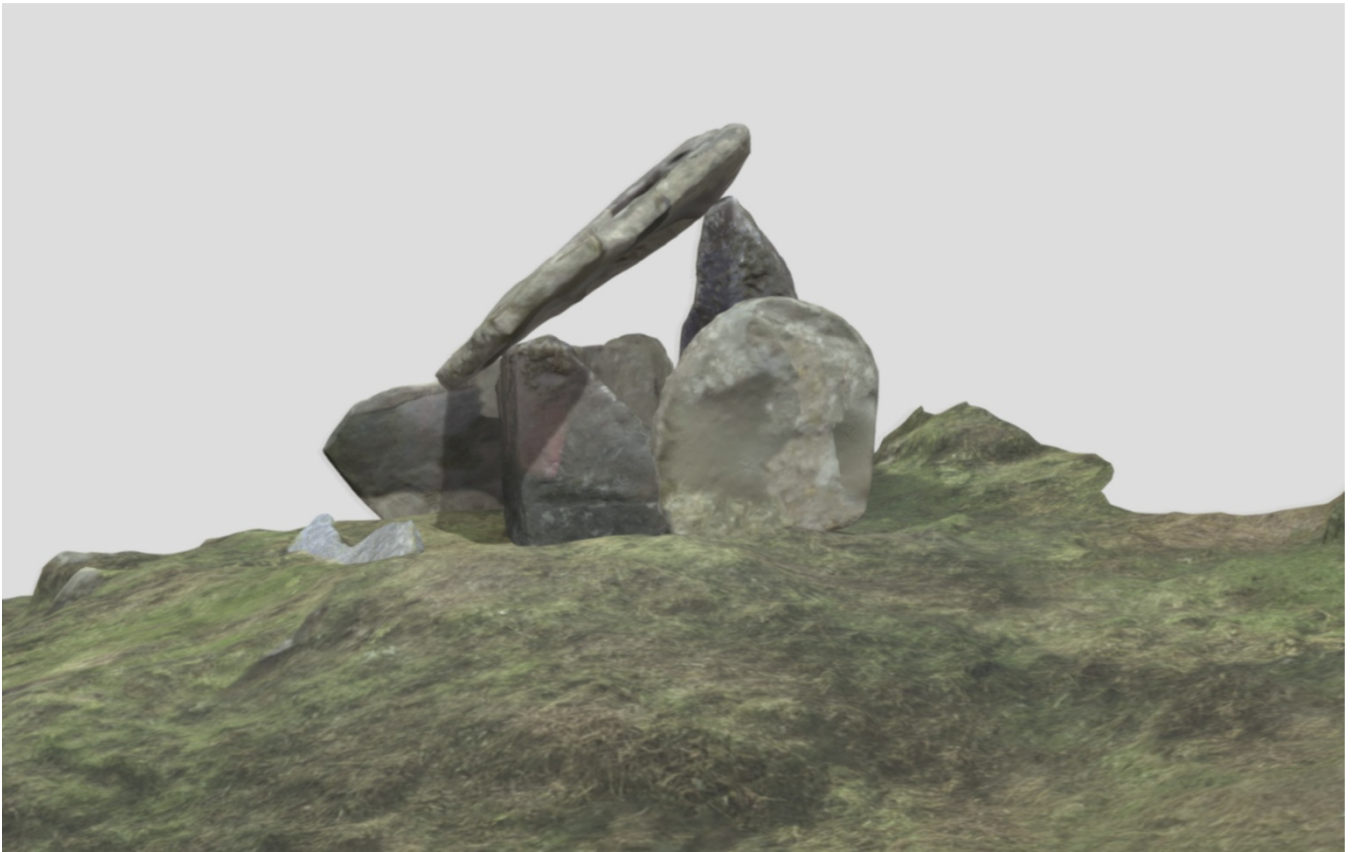
Fig. 3 Reconstruction of site, east facing elevation

The survey was undertaken in such a way as to allow each of the structural elements to be manipulated separately. Consequently it was possible to re-straighten each of the orthostatic elements and to 'reattach' the two broken pieces of the orthostat located to the northeast of the tomb. With this configuration in place, the cap stone was repositioned on the three highest points of the structure; the top of the main portal stone, the top of the smaller southeast orthostat and on the side of the orthostatic side slab (Figs. 3 - 6). The shape of the capstone, square on three sides with the fourth angled, meant that one of the edges was markedly shorter than the other three. Given these constraints, the modeling suggested that there was only a limited number of positions that the capstone could rest satisfactorily on the underlying orthostats. When the post-collapse position of the capstone was factored in it was clear that the straight edge of the capstone must have faced west, with the shorter side facing north and the angled side facing east.

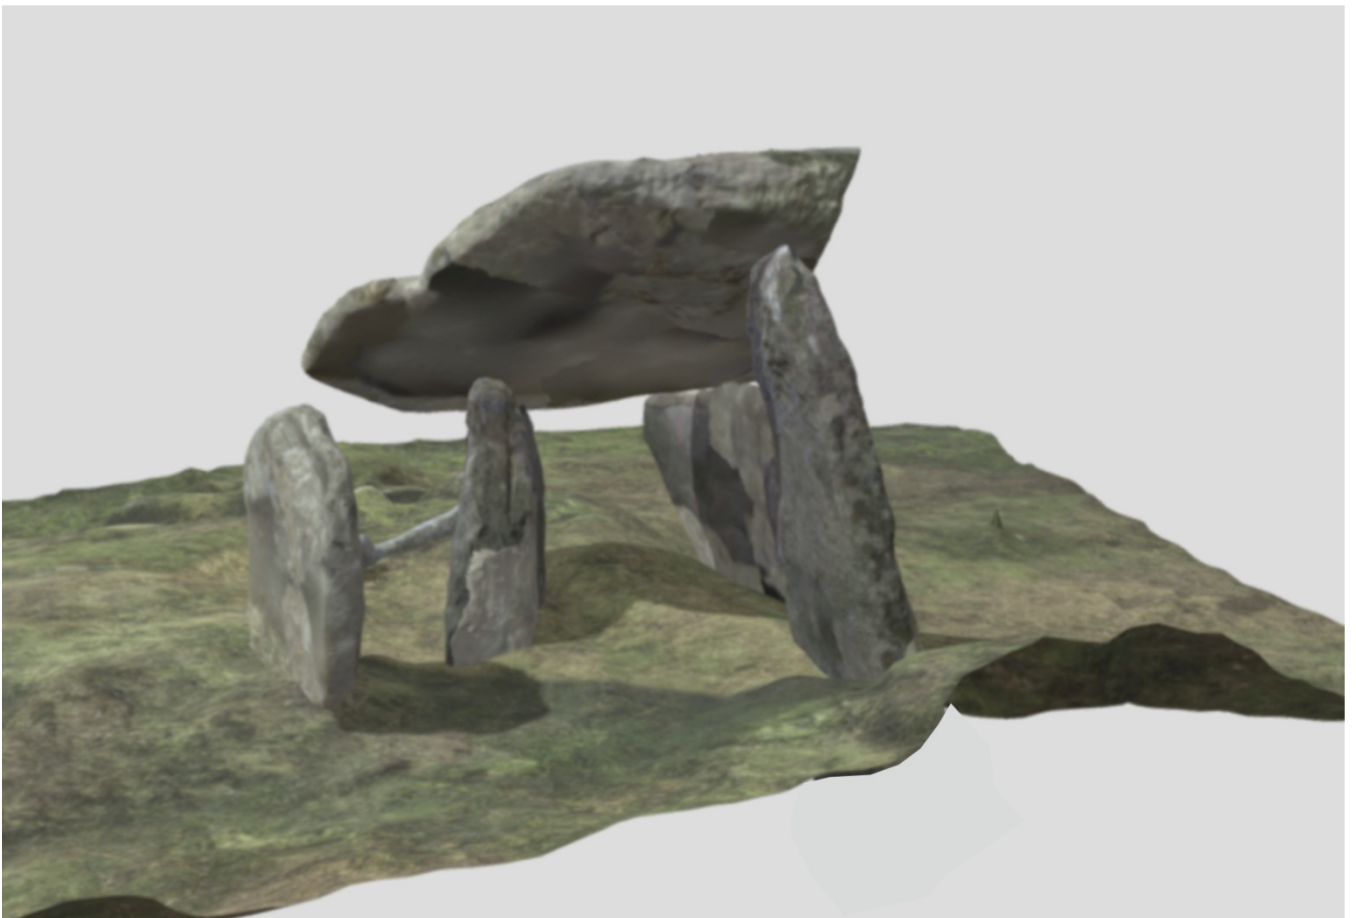
Fig. 4 Reconstruction of site, north facing elevation

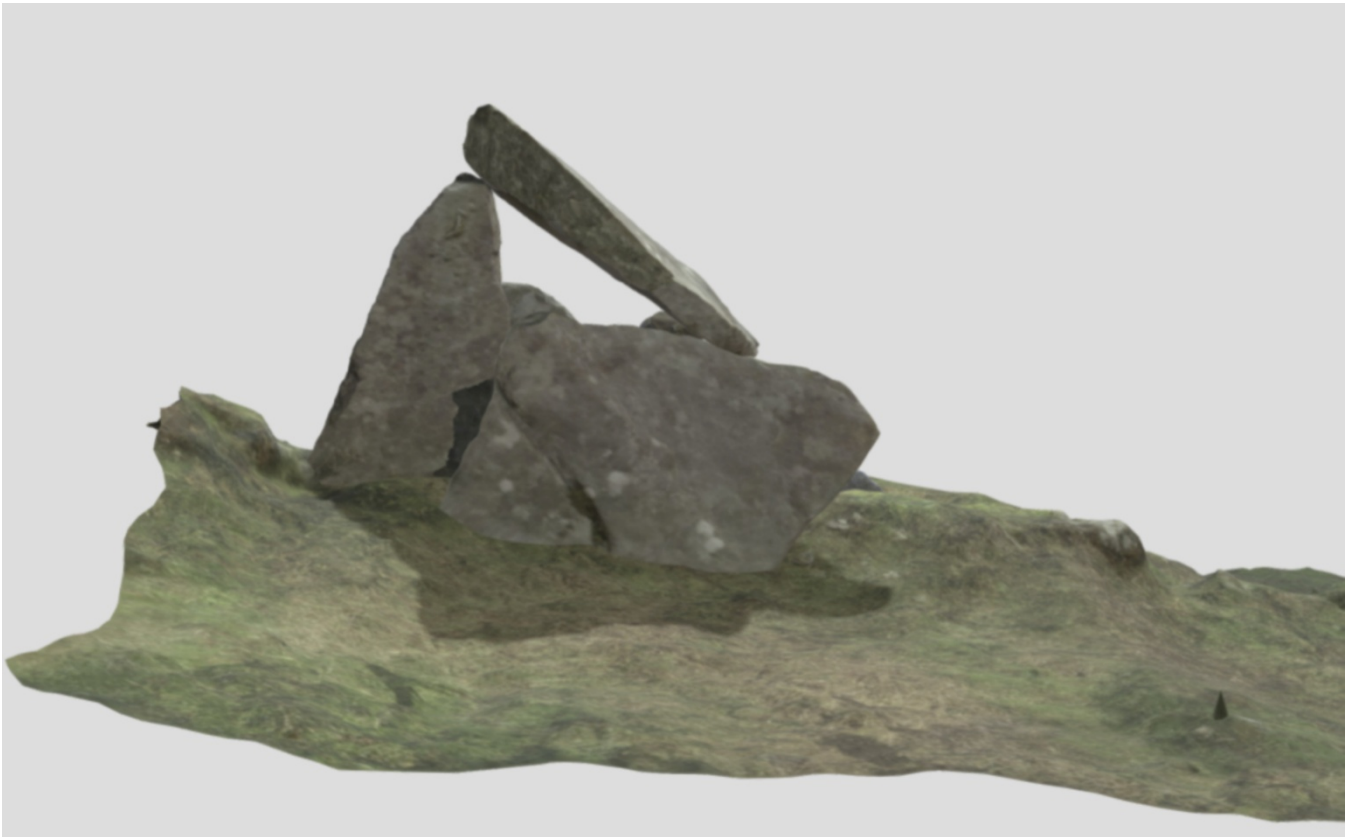
Fig. 5 Reconstruction of site, west facing elevation

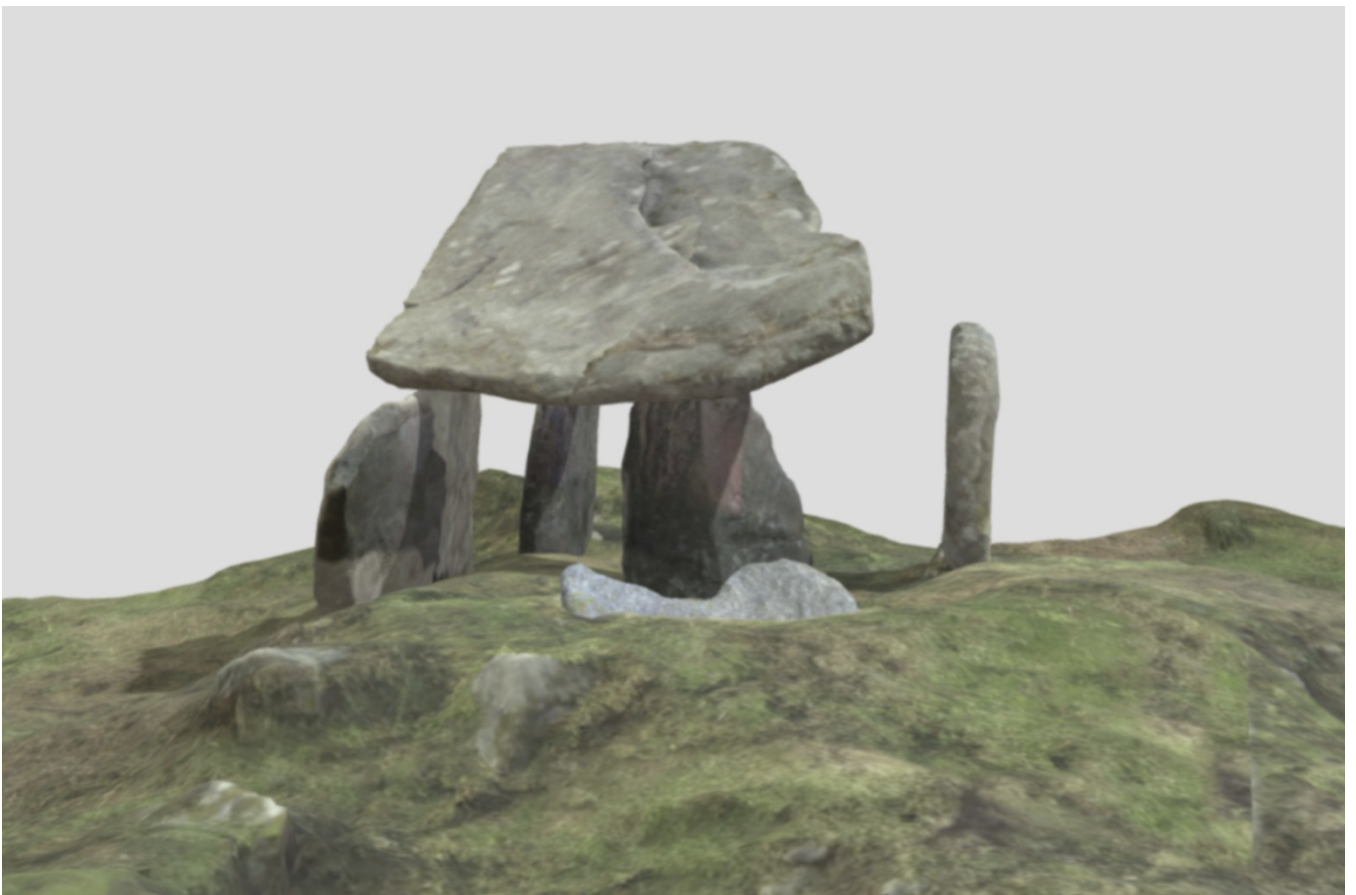
Fig. 6 Reconstruction of site, south facing elevation

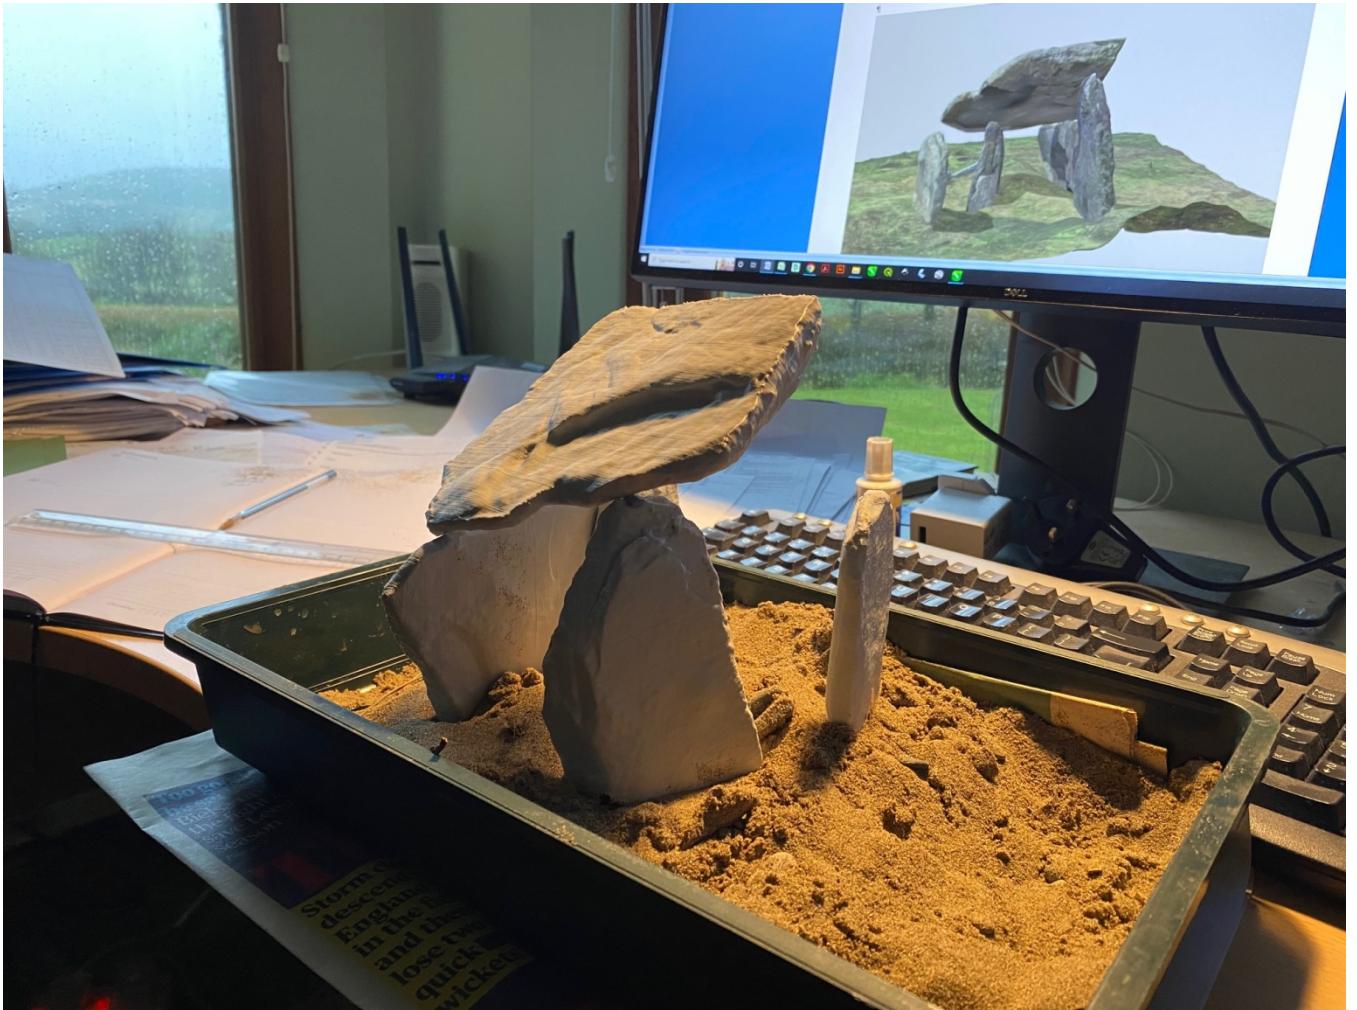
Fig. 7 Laser printed structural elements at 1:20 scale

Finally, the survey allowed for each of the stones to be laser printed at a scale of 1:20, which allows for the proposed virtual reconstructions to be tested manually (Fig. 6).
